ELISHA JONES HOUSE AND SHED

HISTORIC STRUCTURE REPORT

Minute Man National Historical Park
Concord, Massachusetts

James J. Lee III
Architectural Conservator

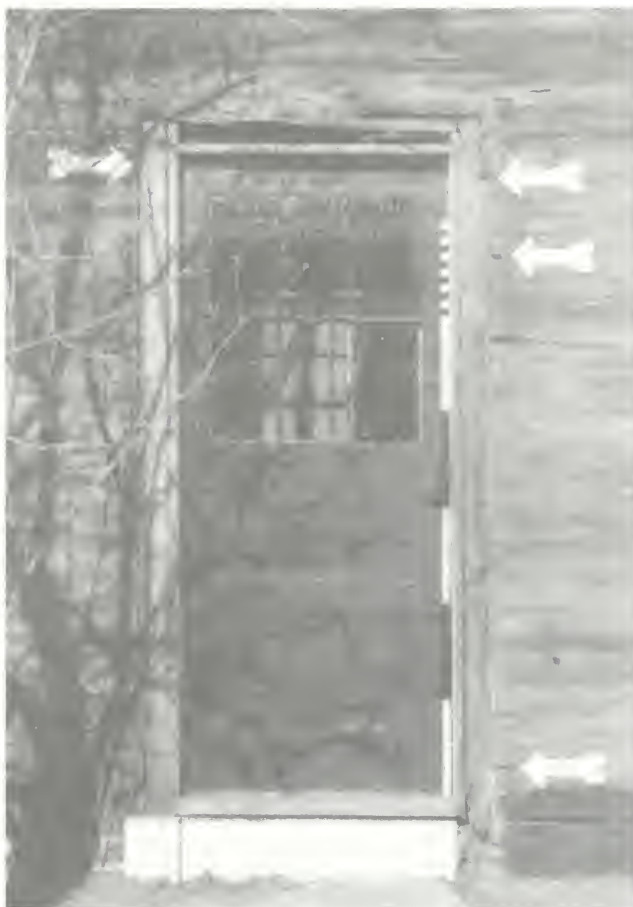
Figure 16. Elisha Jones Shed:
Doorway D107, with arrows
indicating evidence of original
doorway. Upper arrows indicate
height of original doorway, and
lower arrows on right side indicate
holes for original hinge pintles.

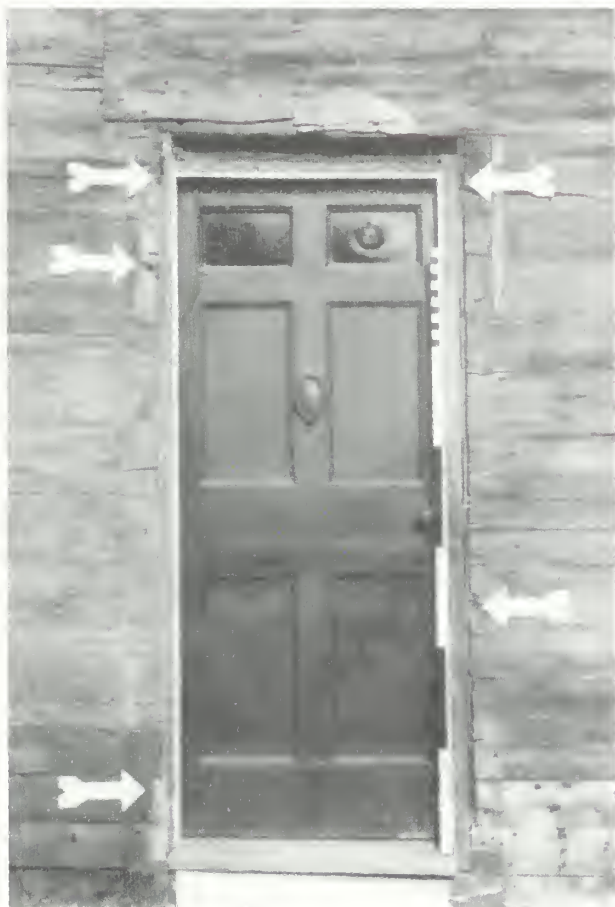
Figure 17. Elisha Jones Shed:
Doorway D108, with arrows
indicating evidence of original
doorway. Upper arrows indicate
height of original doorway; lower
arrows on left side indicate holes
for original hinge pintles; and
lower arrow on right indicates
location of early latch.

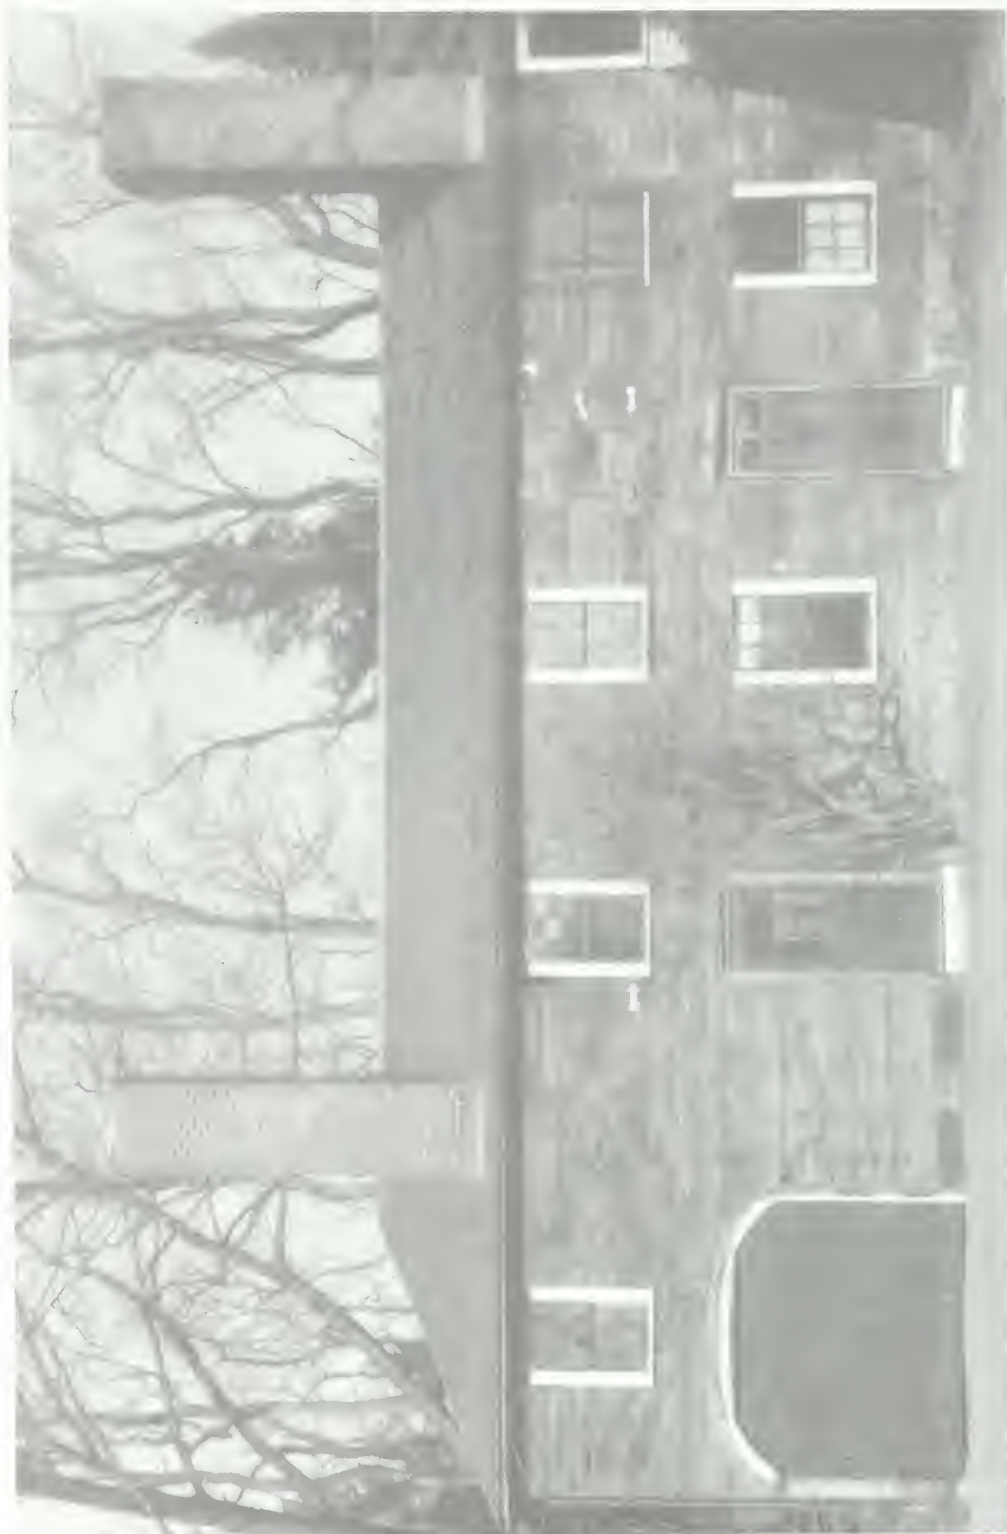
Figure 18. Elisha Jones Shed: West elevation, with arrows indicating evidence of original window openings. The left window (W/224) was reused by John Keyes, and the right one was boarded over in 1865.

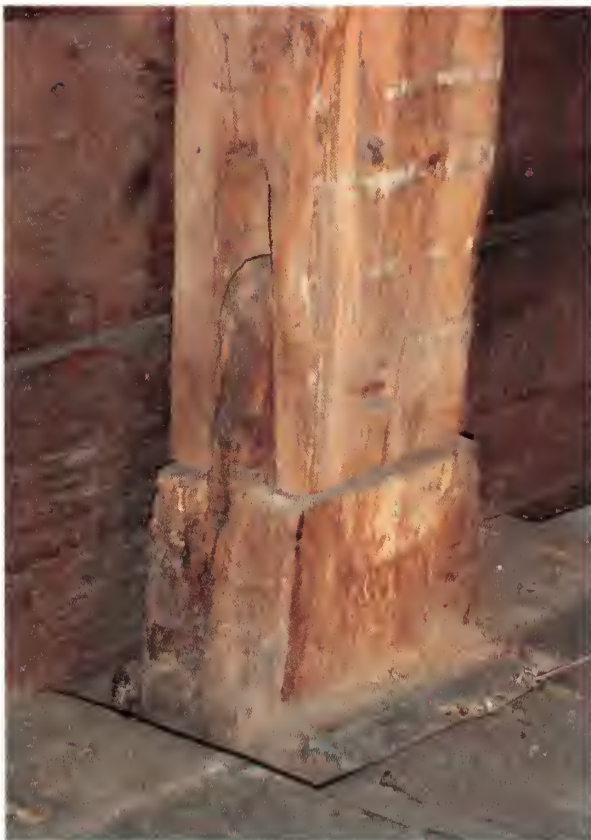
Figure 23. Elisha Jones Shed:
Spliced timber on east elevation
of second story (2006).

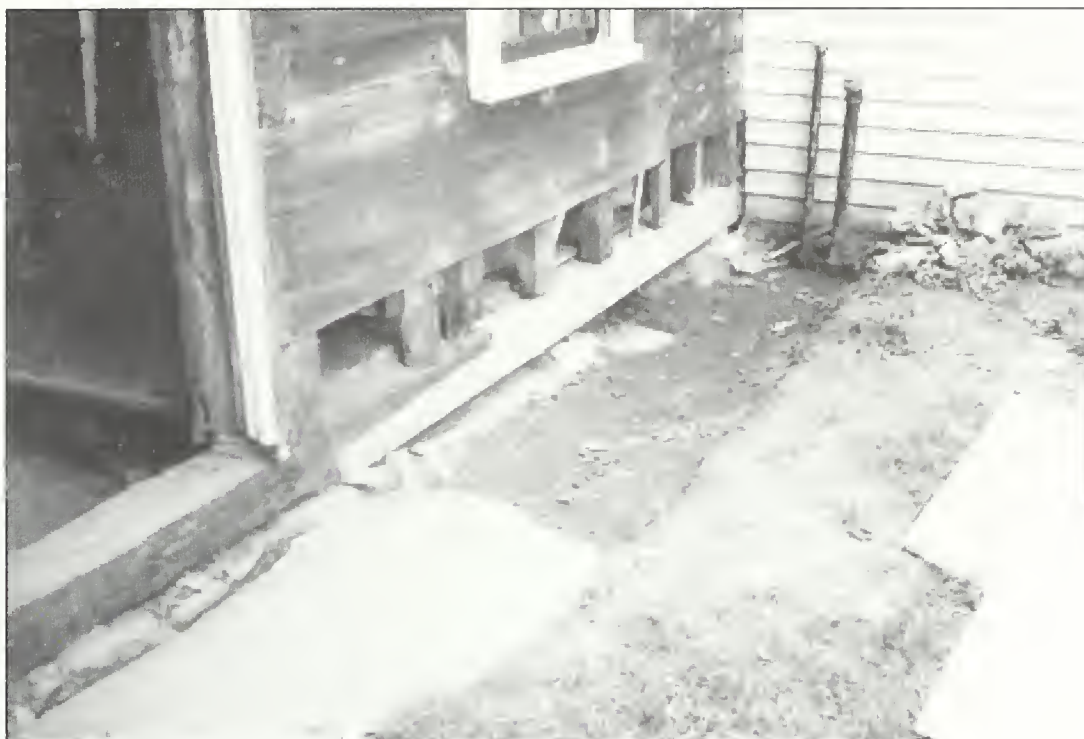
Figure 34. Elisha Jones Shed: West- wall sill repairs at south end of building, with a section of original sill (at left side of photograph) intact, 1974.

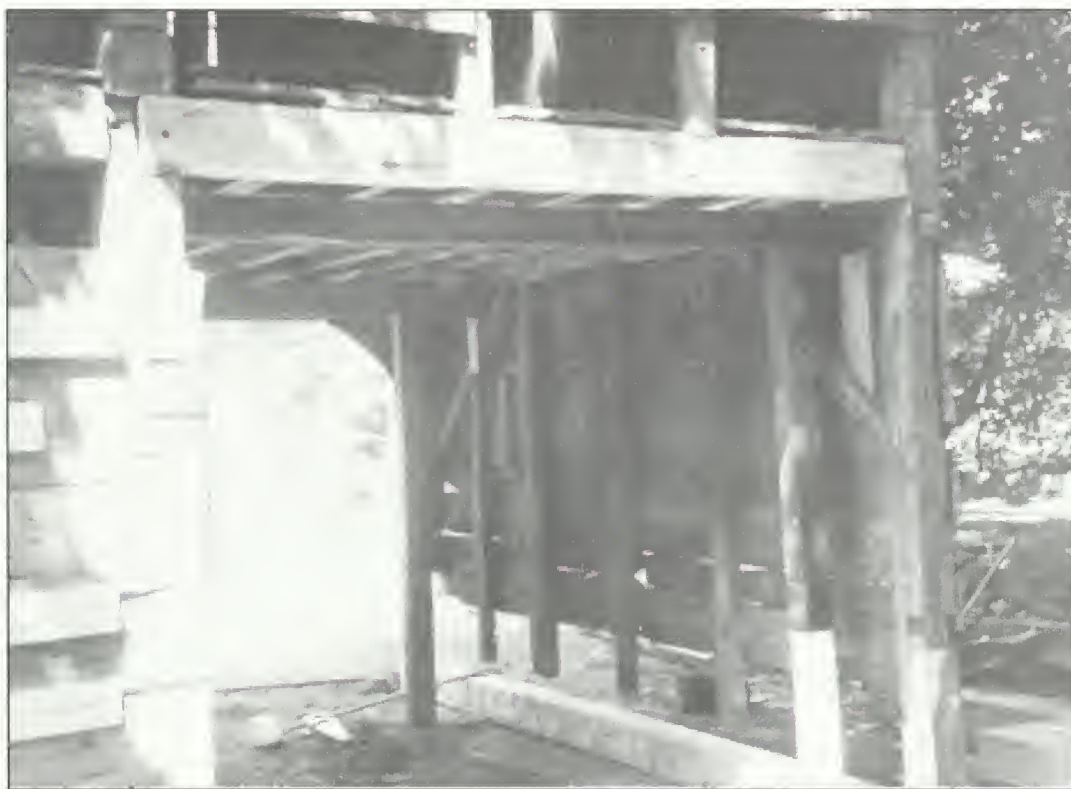
Figure 35. Elisha Jones Shed: East and north wall repairs, including replacement of east- wall girt and north- wall sill, and splicing of posts and studs, 1974.

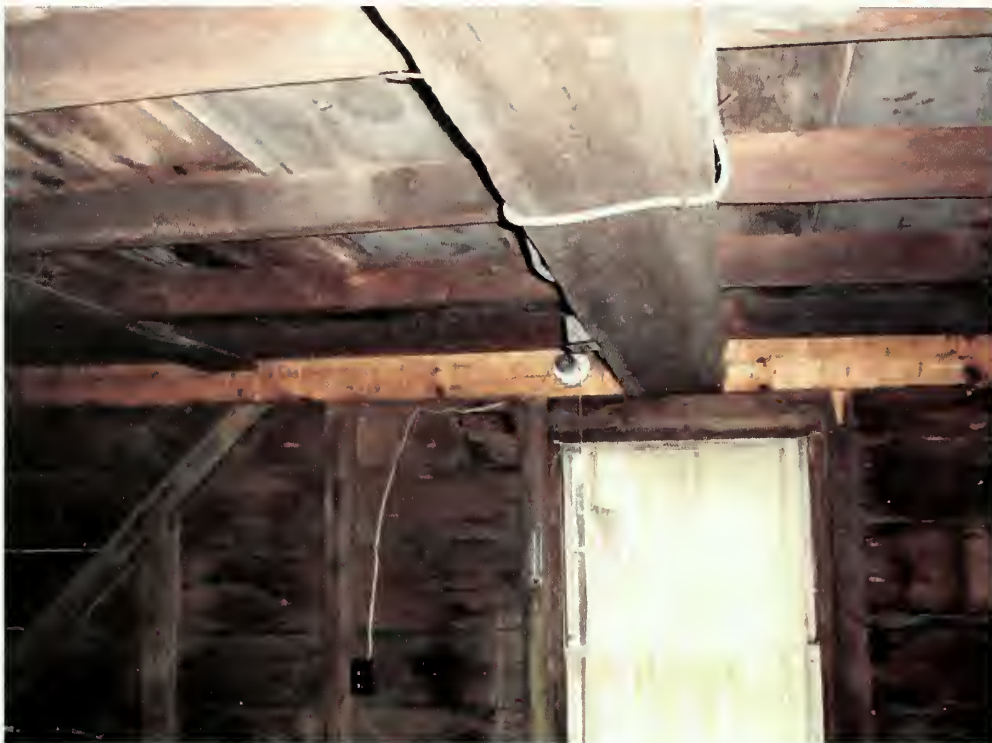
Figure 62. Elisha Jones Shed: Shed Room 104, east wall, exposed framing including summer beam, 1974 replacement girt, studding, and bracing (2006).

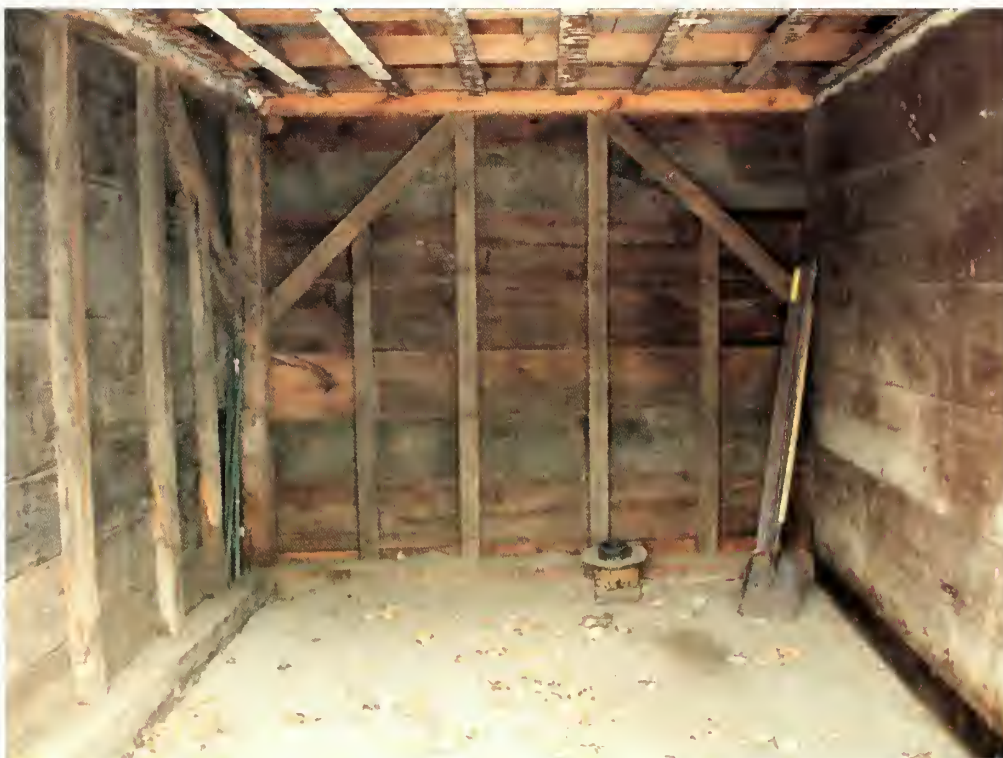
Figure 63. Elisha Jones Shed: Chaise stall, north and east walls, exposed framing including 1974 replacement sill and east girt, spliced studding and corner post, and bracing (2006).
